# COMMISSION OF INQUIRY HINTON TRAIN COLLISION

REPORT OF THE COMMISSIONER  
THE HONOURABLE MR. JUSTICE RENÉ P. FOISY  
DECEMBER, 1986

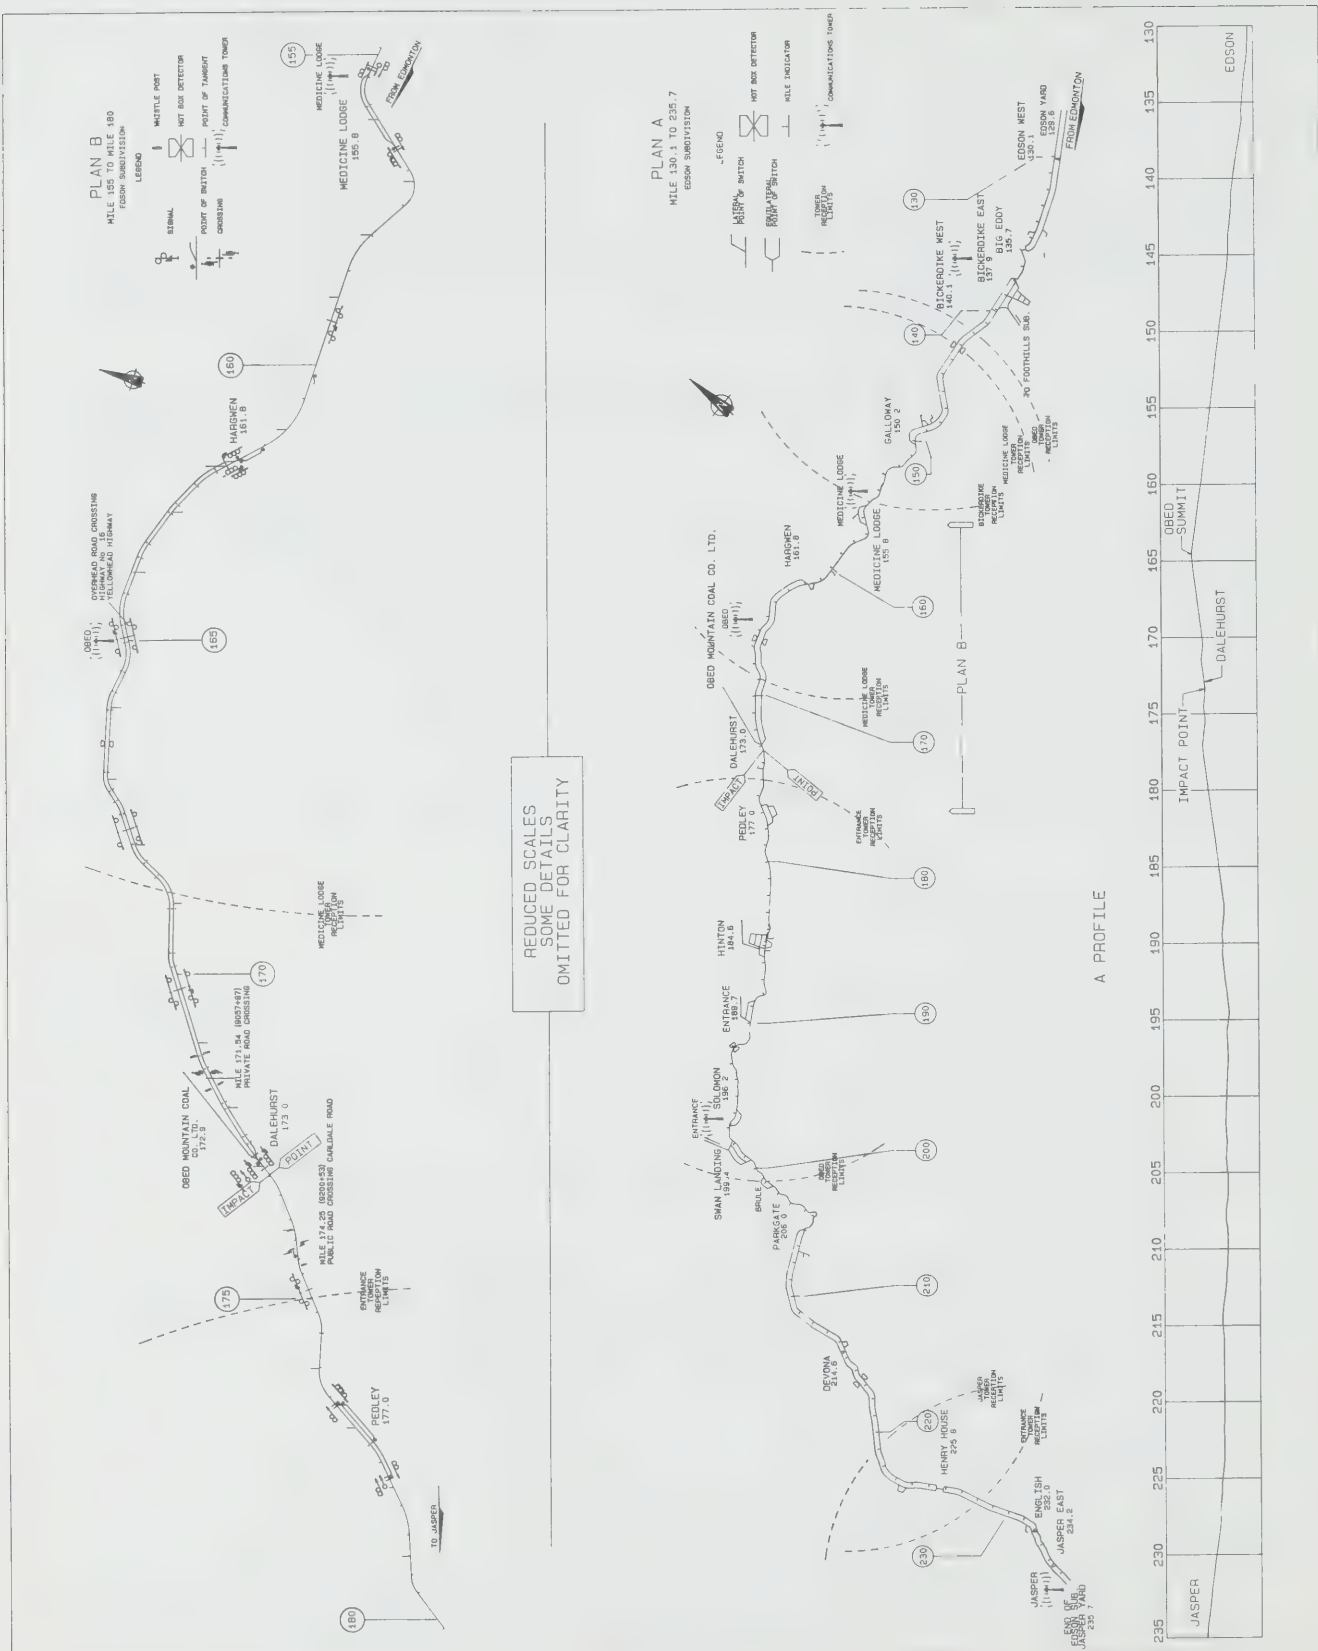
FIGURE 1  
MAP OF EDSON SUBDIVISION

from Edson is almost entirely ascending. The elevation gain is about 580 feet in that distance. The steepness of the grade over the whole ascending section averages about 0.3% and ranges as high as 0.67%. The average grade becomes generally steeper as the track proceeds west towards the point known as the Obed Summit located at Mile 164.5.

From the Obed Summit to Dalehurst there is an elevation drop of about 125 feet. The descending grade averages 0.4% over that distance. There is a one mile portion of that section where the elevation rises 5.4 feet creating a “sag or dip” which is of some significance in the evidence of the conductor of Train 413.

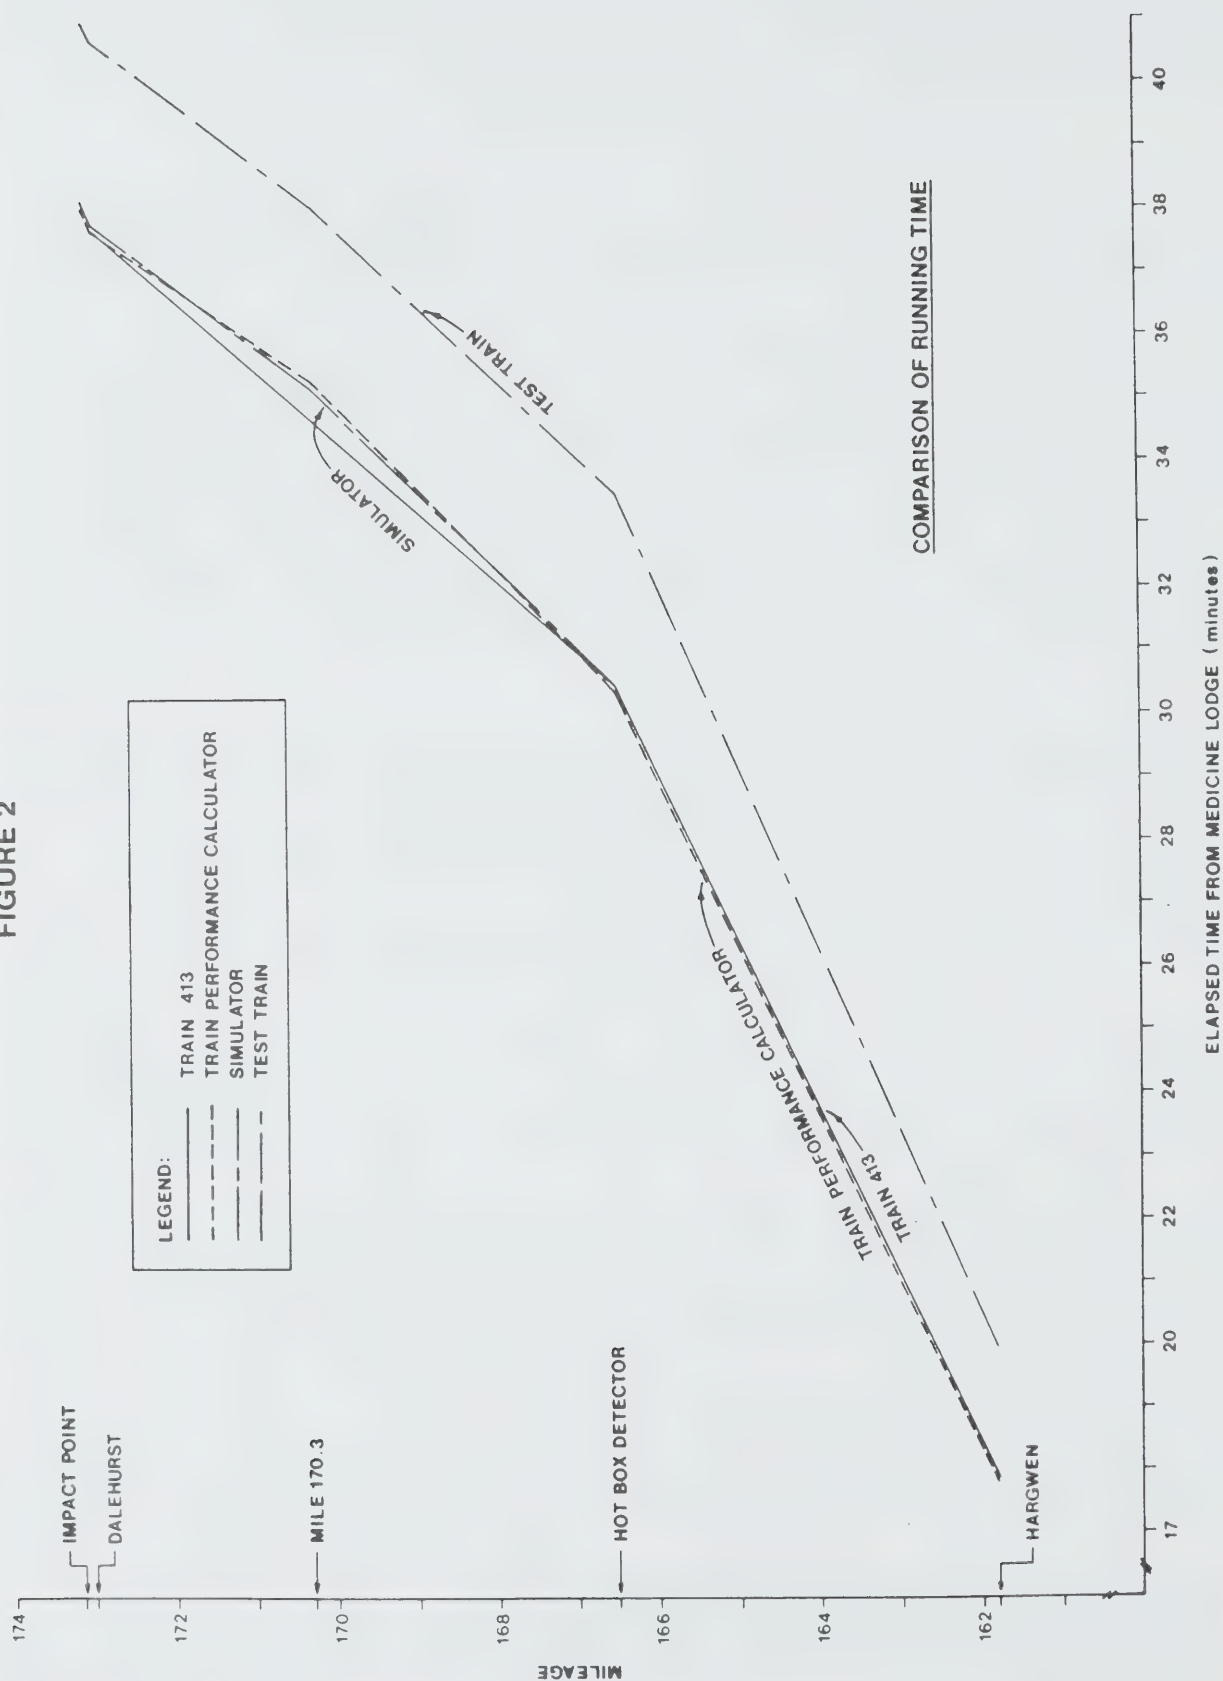
FIGURE 2

The first TPC computer run was initiated from a stop at Medicine Lodge. Full throttle and no braking were assumed from Medicine Lodge to impact. The running times to Hargwen, the hot box detector and Dalehurst were very close to the actual times known about the February 8 run of Train 413. The speed at the hot box detector was also very close to that known of Train 413. The computer train attained a speed of 57.6 miles per hour at Mile 170.2 (the approach signal), 57.4 miles per hour at Dalehurst and 58.7 miles per hour at impact. All of these speeds exceed the 50 mile per hour speed limit set for freight trains on the Edson-Jasper CN line. The results of the TPC simulation are summarized in Table 2 and shown on Figure 2.

CN also used their Train Simulator to recreate the run of Train 413. In this exercise the simulation train's progress was monitored from the hot box detector to impact with a speed of 38 miles per hour at the starting point. The results of this test appear on Table 2 and Figure 2.

At the start of the test, the test train was stopped in the siding at Medicine Lodge. From there it was operated at full throttle without brake application to the point of impact. The time that it arrived at each mileboard and at the various points where comparison with Train 413's arrival time is possible, were noted. The speed of the test train as indicated by the train's speedometer at each of these points was noted. At 5 points the speed was also determined by radar. The results of this test are shown in Table 2 and Figure 2.

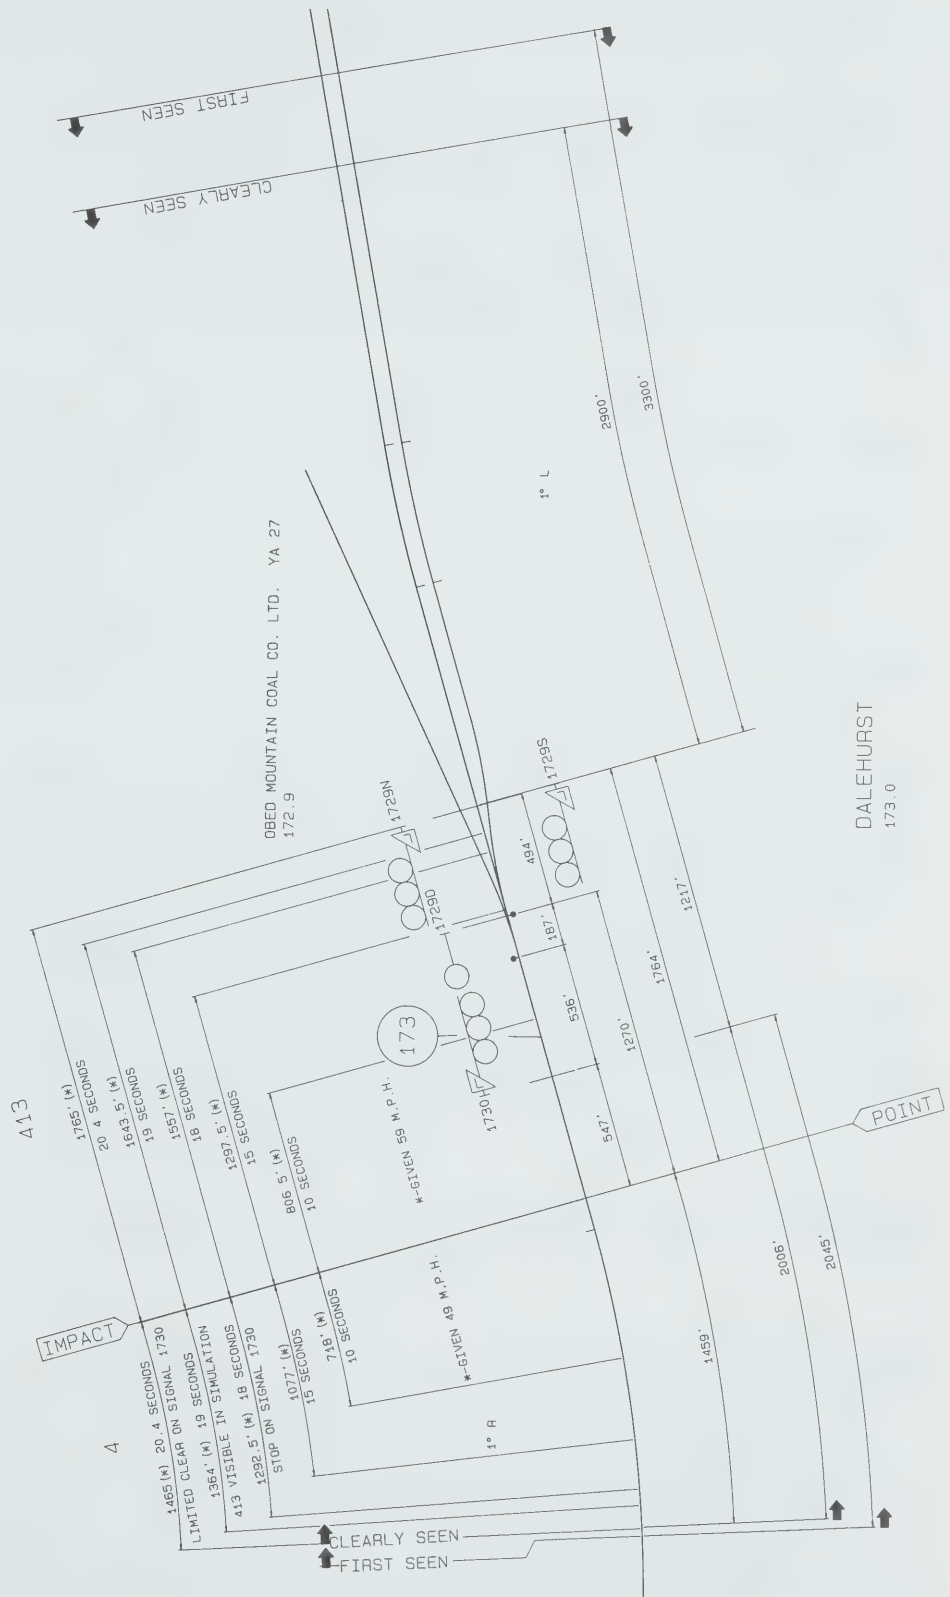
### FIGURE 3

From observations made by moving two locomotives gradually back in both directions from the point of impact and assuming speeds of 59 miles per hour and 49 miles per hour for Trains 413 and 4, respectively, CN prepared an analysis of the collision events. The results are depicted in Figure 3 on page 73. The validity of the assumptions used in this analysis is reviewed later.

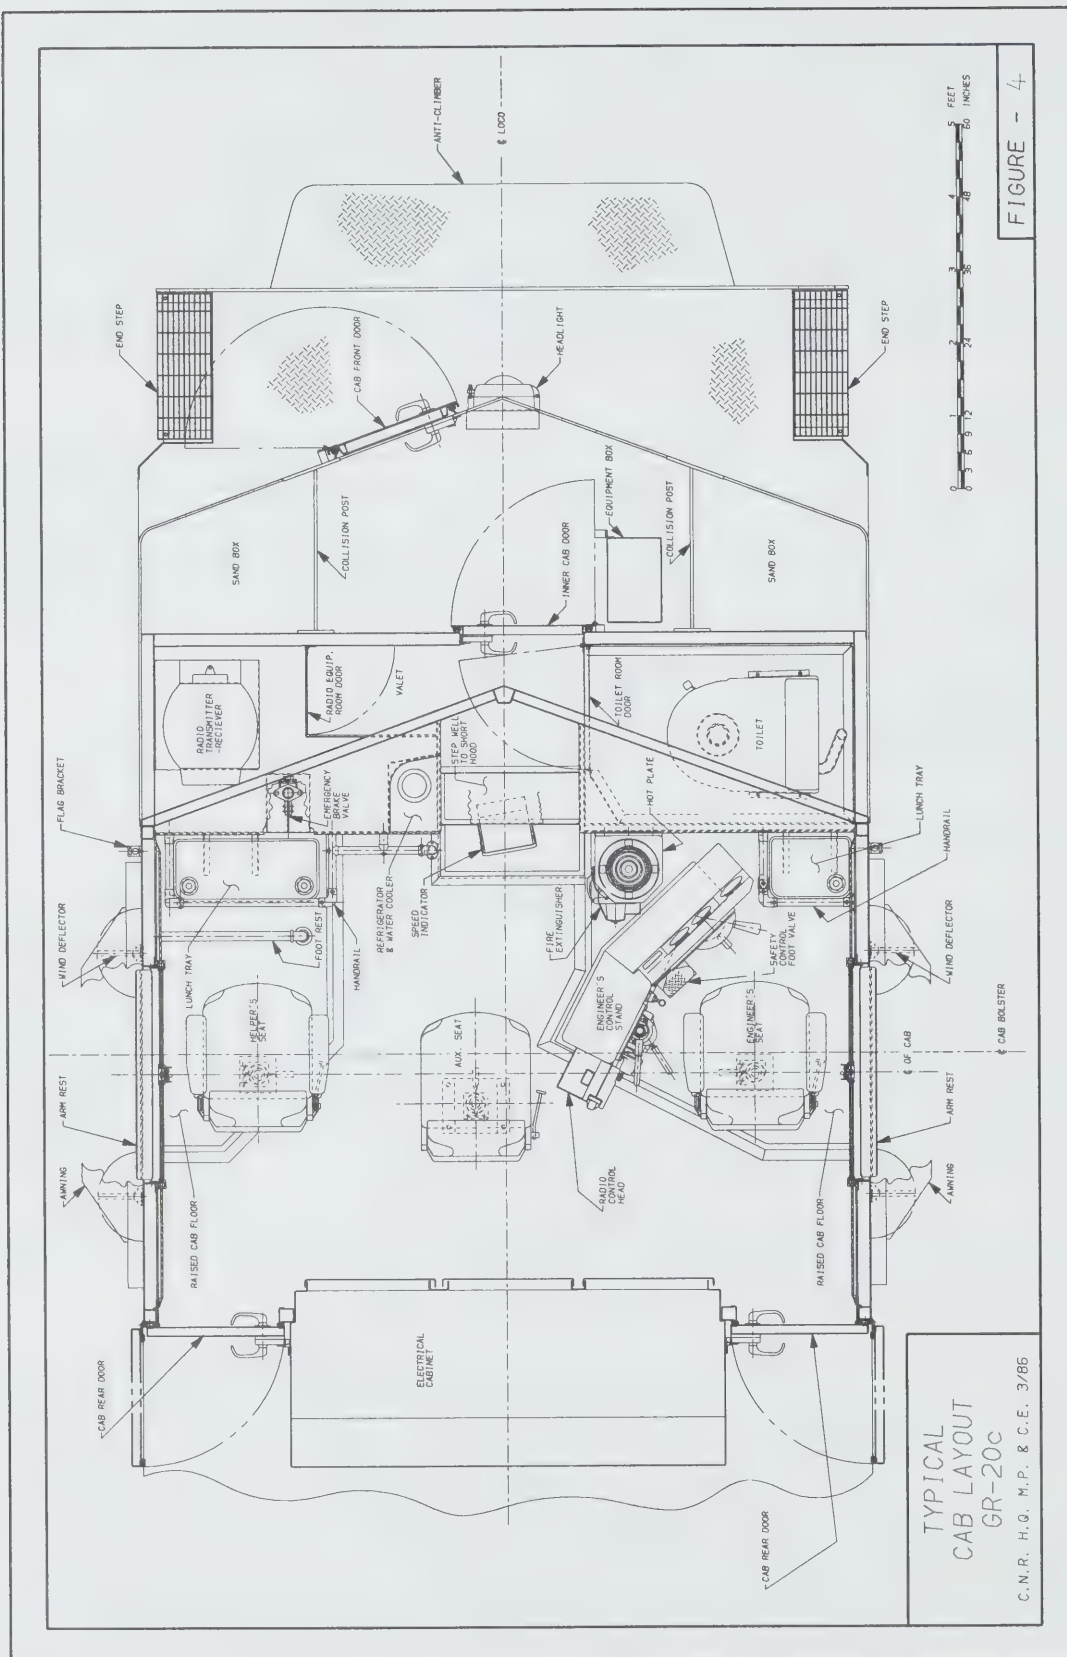
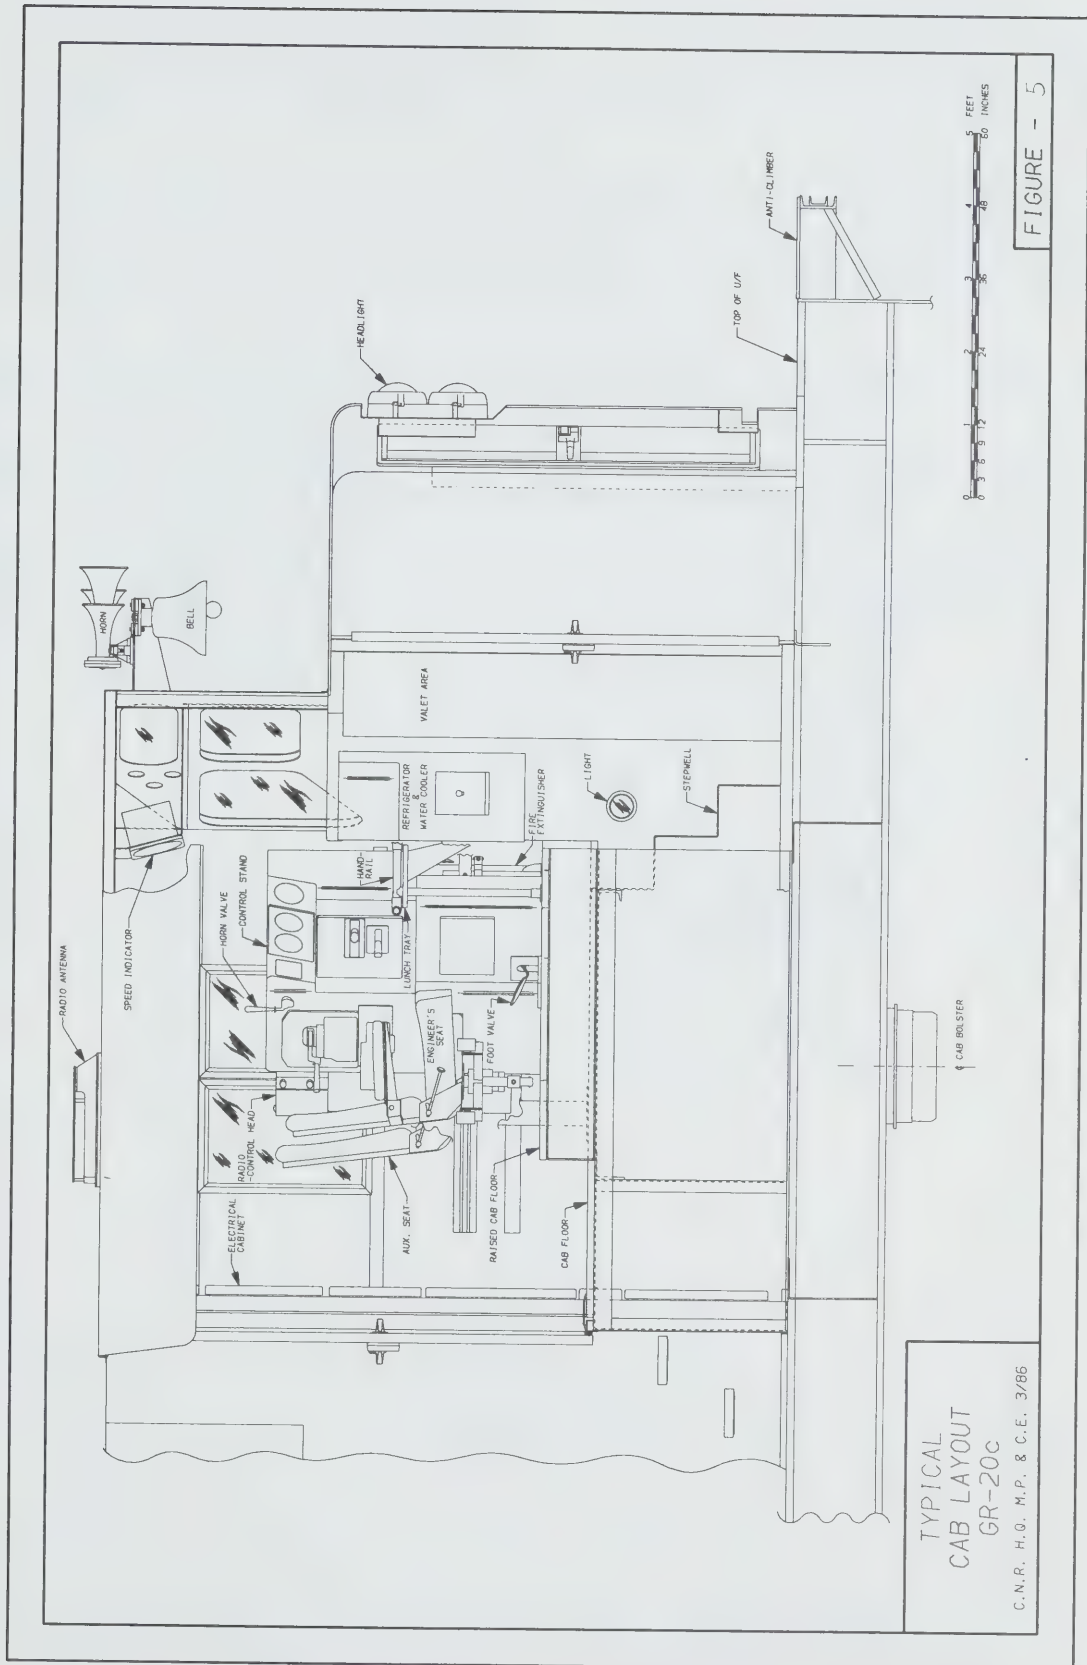
The layout of the cab of the lead unit of Train 413 is depicted in Figures 4 and 5. The cab was classified by CN as a “comfort cab” meaning only that it had certain features which were intended to render it more comfortable than the previous generation of cabs.

The interior layout of the cab of Engine 5586 is depicted in Figures 4 and 5. In front of the locomotive engineer's seat and a few steps down from the floor on which the seat is positioned, is a small toilet room. Hudson's remains were found against the material which had formed the upper forward corner wall of this room. The suggestion was that this indicated that at the time of the collision Hudson was in the toilet room and not in his seat.
